DEPARTMENT OF TRANSPORTATION

Contract #: 04-0120F4Cty: SF/ALA Rte: 80 PM: 13.2/13.9File #: 1.28**WELDING INSPECTION REPORT****Resident Engineer:**Siegenthaler, Peter**Address:** 333 Burma Road**City:** Oakland, CA 94607**Report No:** WIR-022032**Date Inspected:** 17-Mar-2011**Project Name:** SAS Superstructure**OSM Arrival Time:** 630**Prime Contractor:** American Bridge/Fluor Enterprises, a JV**OSM Departure Time:** 1500**Contractor:** American Bridge/Fluor Enterprises, a JV**Location:** Job Site**CWI Name:** See below**CWI Present:** Yes No**Inspected CWI report:** Yes No N/A**Rod Oven in Use:** Yes No N/A**Electrode to specification:** Yes No N/A**Weld Procedures Followed:** Yes No N/A**Qualified Welders:** Yes No N/A**Verified Joint Fit-up:** Yes No N/A**Approved Drawings:** Yes No N/A**Approved WPS:** Yes No N/A**Delayed / Cancelled:** Yes No N/A**Bridge No:** 34-0006**Component:** SAS OBG**Summary of Items Observed:**

WELDING INSPECTION REPORT

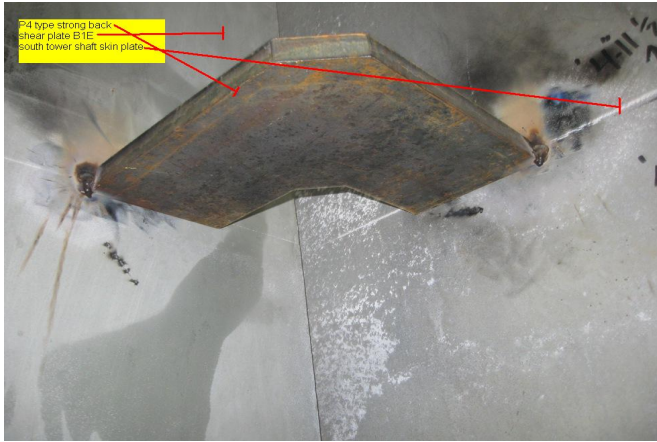
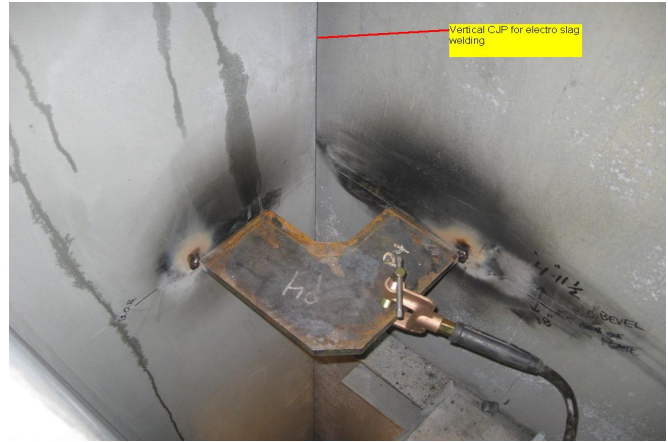
South tower leg to shear plate identified as B1E complete joint penetration electro slag weld joint. The QA Inspector randomly observed the ABF Welding Superintendent Dan Ieraci and the ABF welder Kenneth Chapel installing and tack welding the weld joint restraint plates or strong backs to the weld joint identified above. The QA Inspector noted the temporary attachment was identified as a P4 type strong back. The QA Inspector noted the ends of the plate have a single bevel to be welded utilizing a partial joint penetration groove weld at both ends of the attachment form the 2G welding position. The QA Inspector noted for clarification, one end of the plate gets welded to the B1E shear plate and the other end of the plate is welded to the outer skin of the south tower shaft. The QA Inspector noted no weld other than shielded metal arc welding (SMAW) tack welding was performed on

this date. The QA Inspector observed Mr. Ieraci preheat the isolated area adjacent to the electro slag vertical weld joint to 225°F utilizing a rose bud torch. After the minimum required preheat was achieved, Mr. Ieraci would hold the plate in place while the ABF welder Kenneth Chapel performed SMAW tack weld on the edge of the P4 type strong back and not in the PJP groove to be welded at a later time. The QA Inspector noted the ABF welder was utilizing 1/8" E7018 low hydrogen electrodes with 130 Amps. It was noted the minimum required preheat and SMAW parameters did appear to be in general compliance with the contract requirements. The QA Inspector noted the SE QC Inspector Patrick Swain was on sit to monitor the in process tack welding and fit up. The QA Inspector noted the same process was repeated twice for the above identified weld joint and again for the weld joint identified as shear plate B2E to the south tower shaft outer skin plate. The QA Inspector noted no welding other than tack welding was performed on this date. (Observed the pictures below for clarification) The QA Inspector noted when the flux cored arc welding is performed to attach the restraint plates the welding does appear it will be performed in the heat affected zone (HAZ) of the CJP vertical electro slag weld joint.
